26 APRIL 2009 - UPDATE 6

# UPDATED ANALYSIS REPORT (19 APRIL 2009) SATELLITE-DETECTED DAMAGES AND IDP SHELTER MOVEMENT IN CSZ, MULATTIVU DISTRICT, SRI LANKA

SATELLITE IMAGERY DATES: 19 APRIL, 29-6 MARCH, 19-5 FEB. 2009

ANALYSIS : UNOSAT

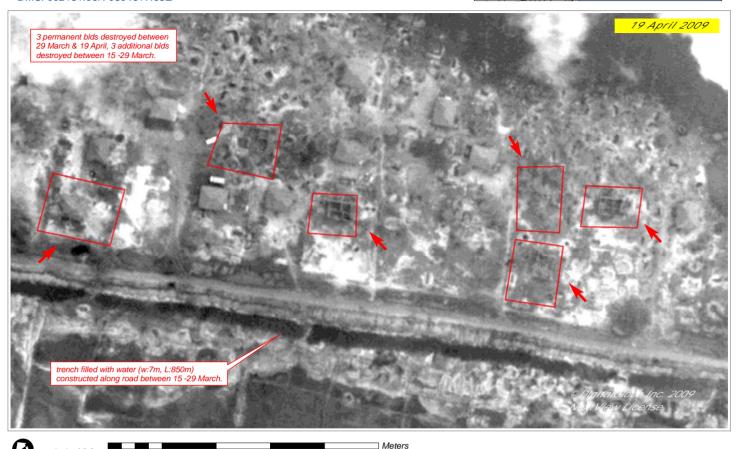
# ID: 229 - 6 BUILDINGS DESTROYED IN NORTHERN CSZ AND TRENCH FORMATION .. Page 3

- 1. **Putumattalan:** Three permanent buildings have been destroyed between 29 March and 19 April, bringing the total for the northern section of the CSZ to six destroyed since 15 March. There are potentially large amounts of moderate to severe damages to the remaining permanent buildings in this area.
- **2. Valayanmadam**: 1 additional permanent building has been destroyed, and further south there is a cluster of likely impact craters within an area previously densely populated with IDP shelters.

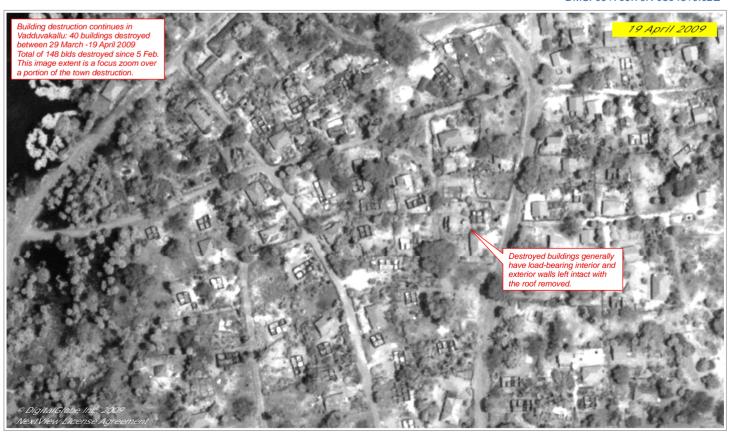
ID: 256 - BUILDING DESTRUCTION CONTINUES IN VADDUVAKALLU SOUTH OF CSZ

- 4. **Vadduvakallu**: Building destruction continues in Vadduvakallu: 40 buildings destroyed between 29 March -19 April 2009 and a total of 148 building destroyed since 5 February 2009. A significant number of buildings were destroyed before 5 February 2009. A complete damage assessment is in progress by UNITAR/UNOSAT.
